Navajo Abandoned Uranium Mine Site Screen Report

Crownpoint ISL Site

Navajo AUM Eastern Region

May 2009

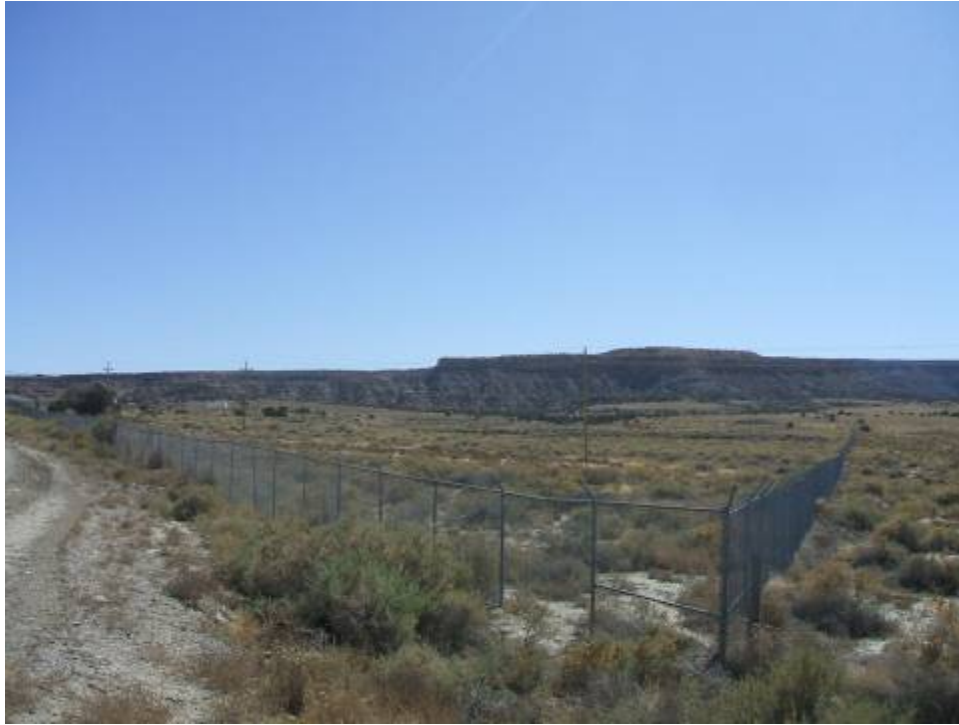
No ownership was identified. The mine site property is classified as Indian Allotment, and Private land. Currently, Hydro Resources, Inc, occupies the property, although the facility is not presently active. The site was fenced in, and field personnel were unable to access the interior of the property (Photo 1, 2).

Photo 1. Crownpoint ISL mine site, towards the southeast

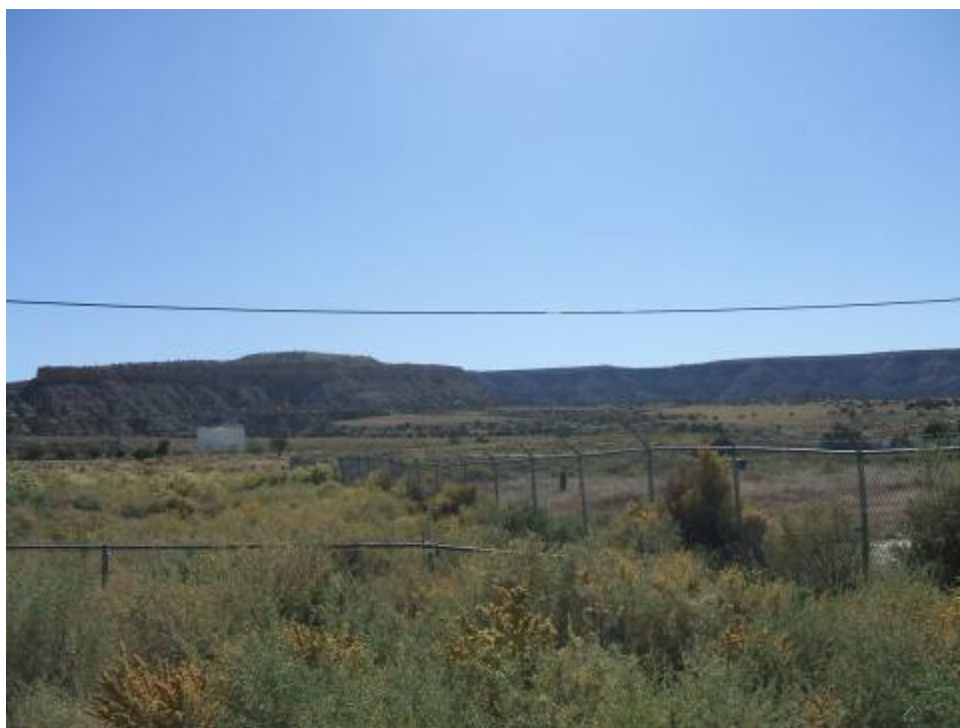
Photo 3. Crownpoint ISL mine site, towards the south

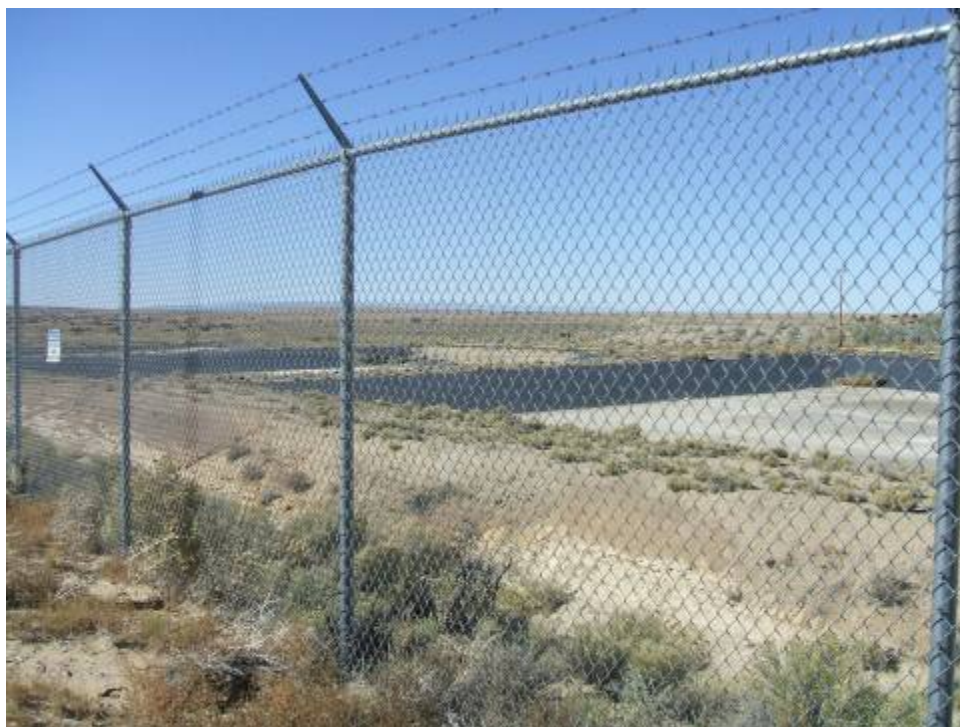
Photo 4. Crownpoint ISL mine site lined ponds, towards the northwest

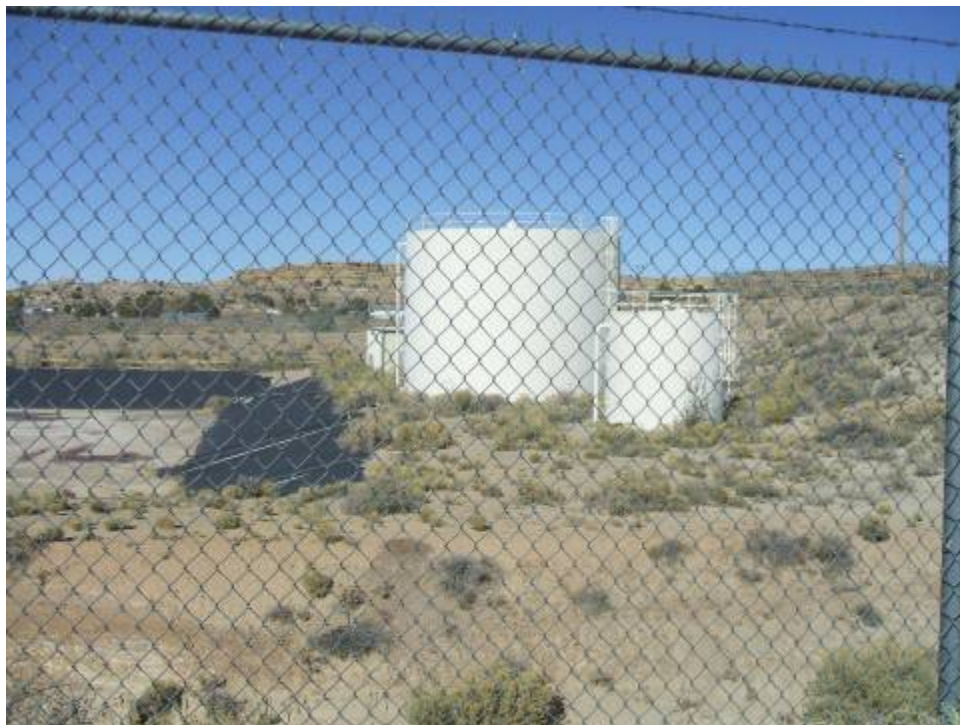
Photo 5. Crownpoint ISL mine site lined ponds and tanks, towards the northwest

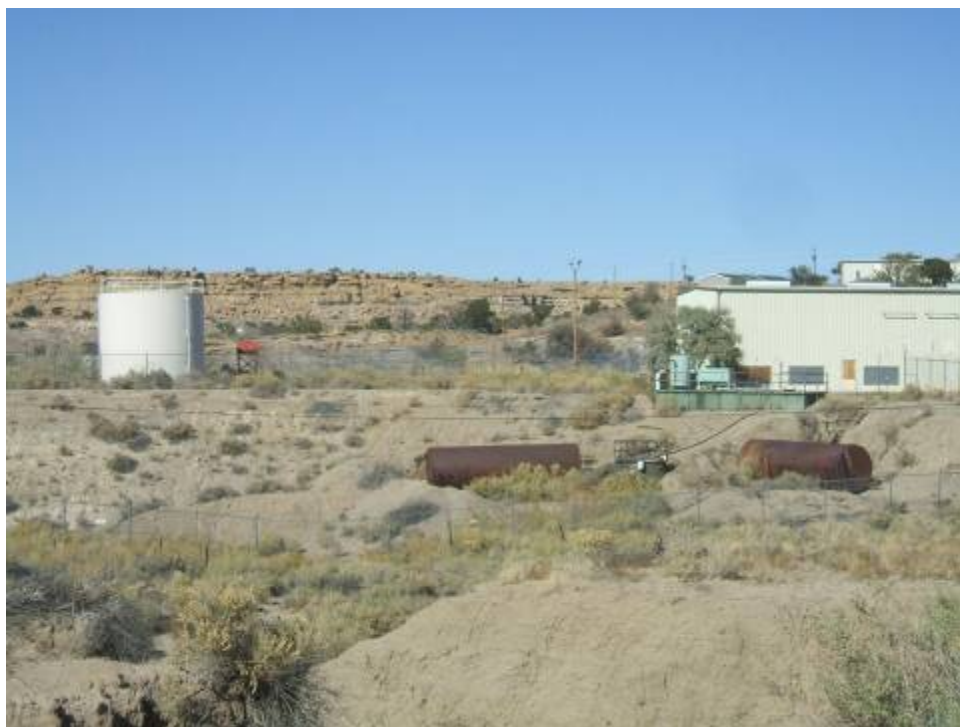
Photo 6. Crownpoint ISL mine site tanks and Hydro Resources building, towards the north

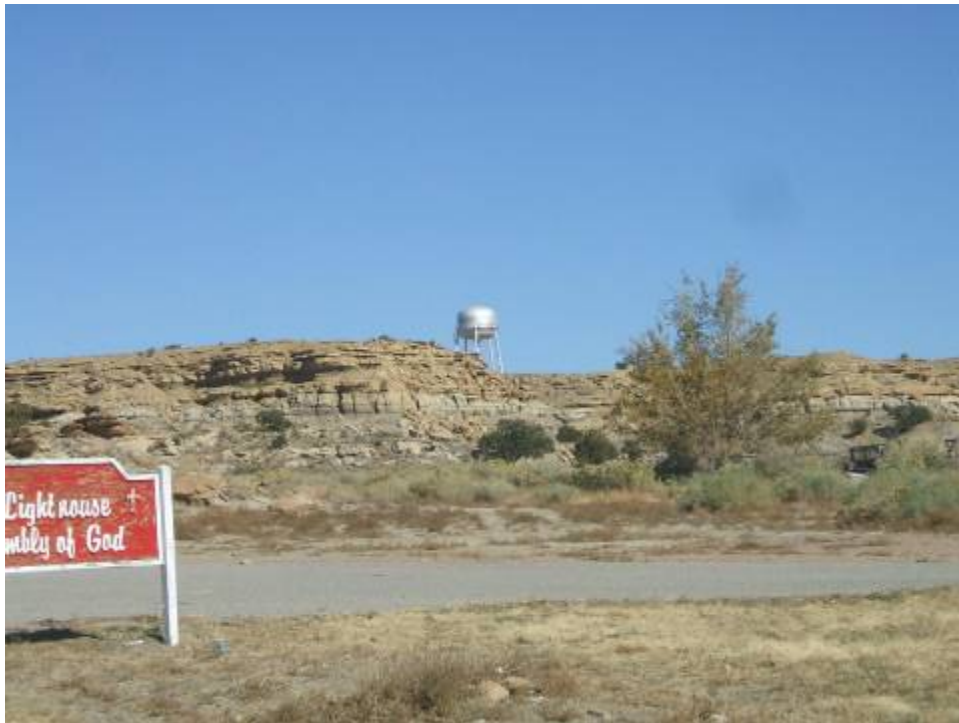
0 to 0.25 miles: None **0.25 miles to 4 miles:** A water tower was observed approximately 0.5 miles north of the site, field personnel were unable to access the tower, and were not able to identify the source of the water.

Photo 8. Water tower approximately 0.5 miles north/northeast of site, towards the northeast

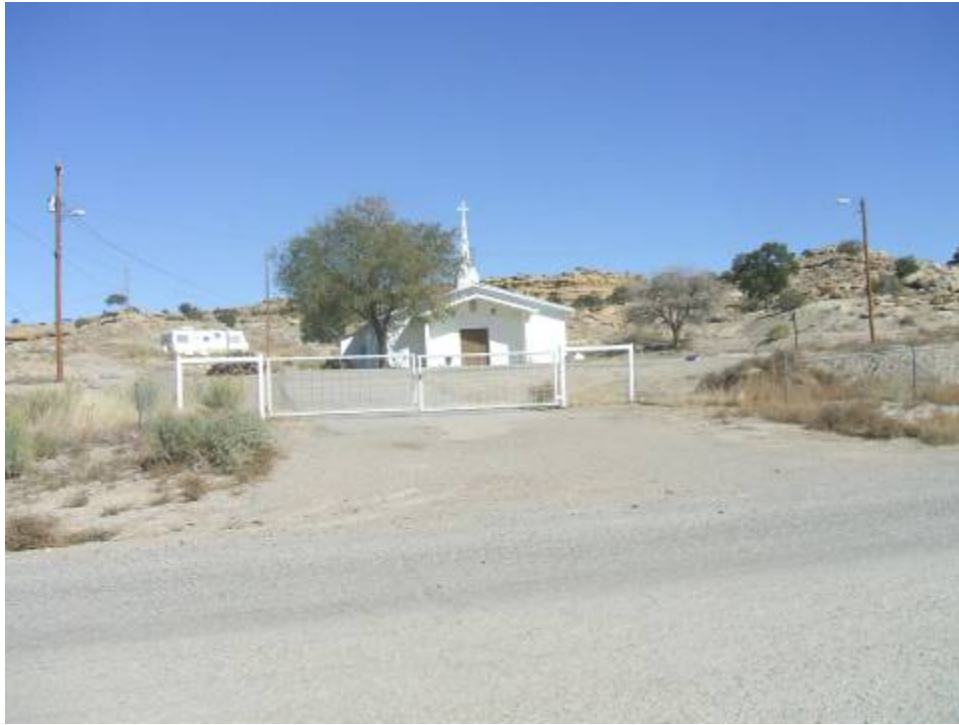
0 to 200 feet: 3 churches were observed within 200 feet of the site property, to the north, along Church Drive (Photo 9, 10). Gamma radiation levels at the churches were found at less than 2 times background levels. **200 feet to 0.25 mile:** None

Photo 9. New Life Fellowship Church, approximately 200 feet north of site, towards the north

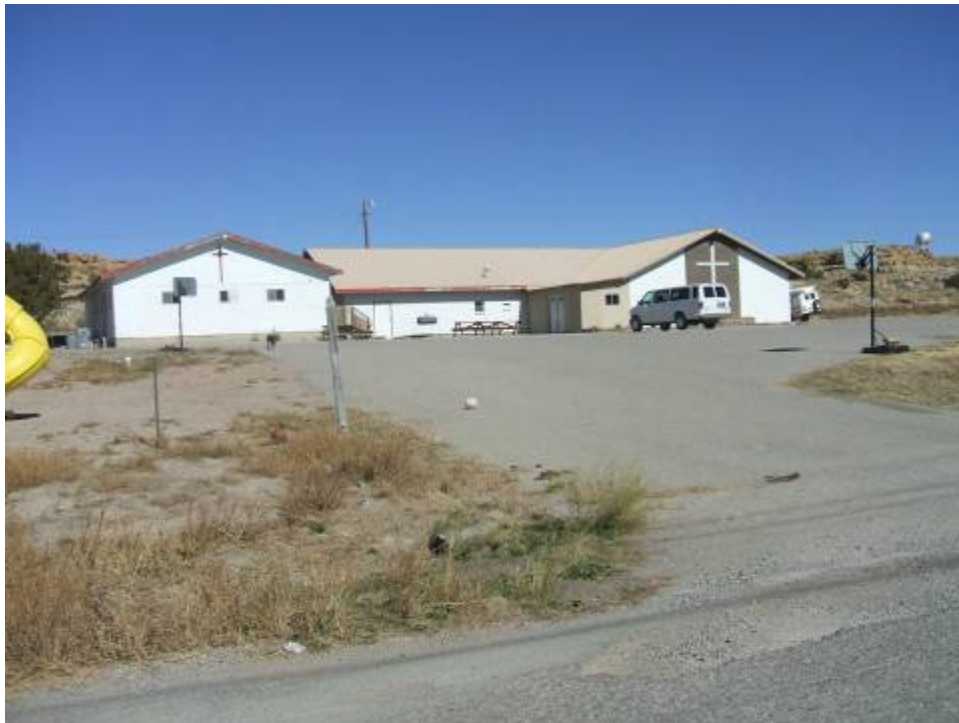
Photo 10. Church at northeast corner of site, towards the northeast

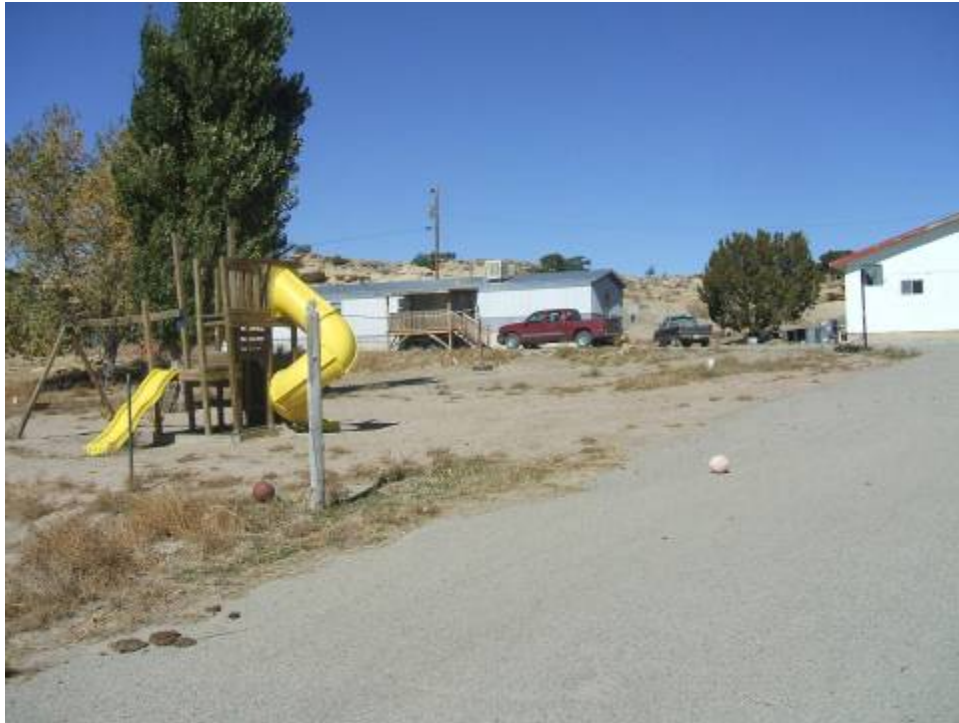
0 to 200 feet: Approximately 6 houses were observed within 200 feet of the site property, to the north, along Church Drive (Photo 11, 12. Gamma radiation levels at the houses were found at less than 2 times background levels. **200 feet to 0.25 mile:** None

Photo 11. Trailer and church at northeast corner of site, towards the northeast

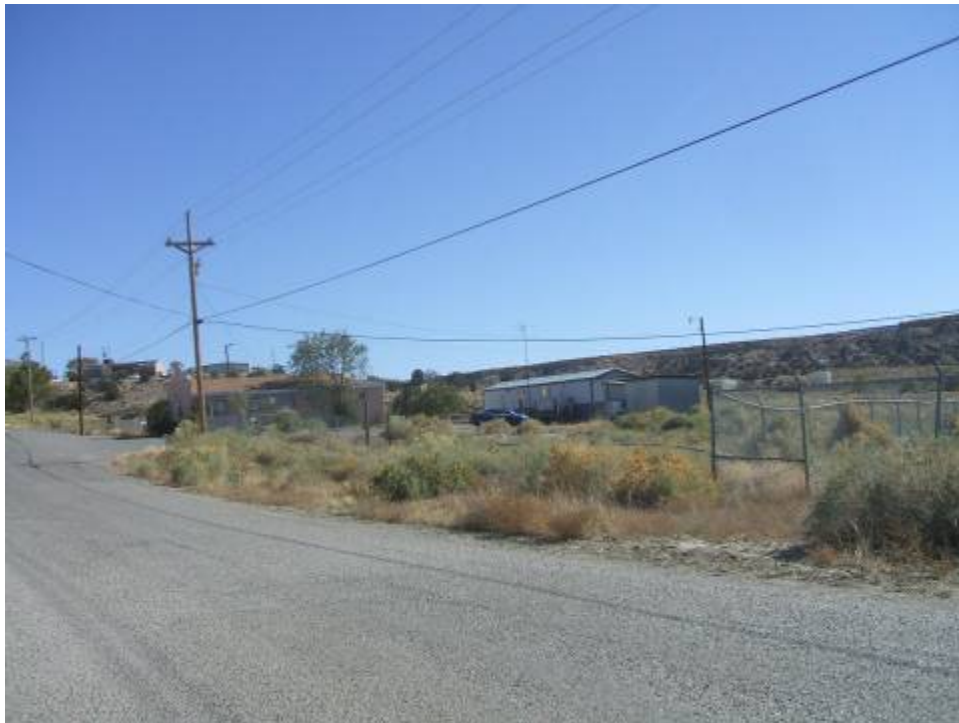
Photo 12. Trailers and houses at northeast corner of site, towards the southeast

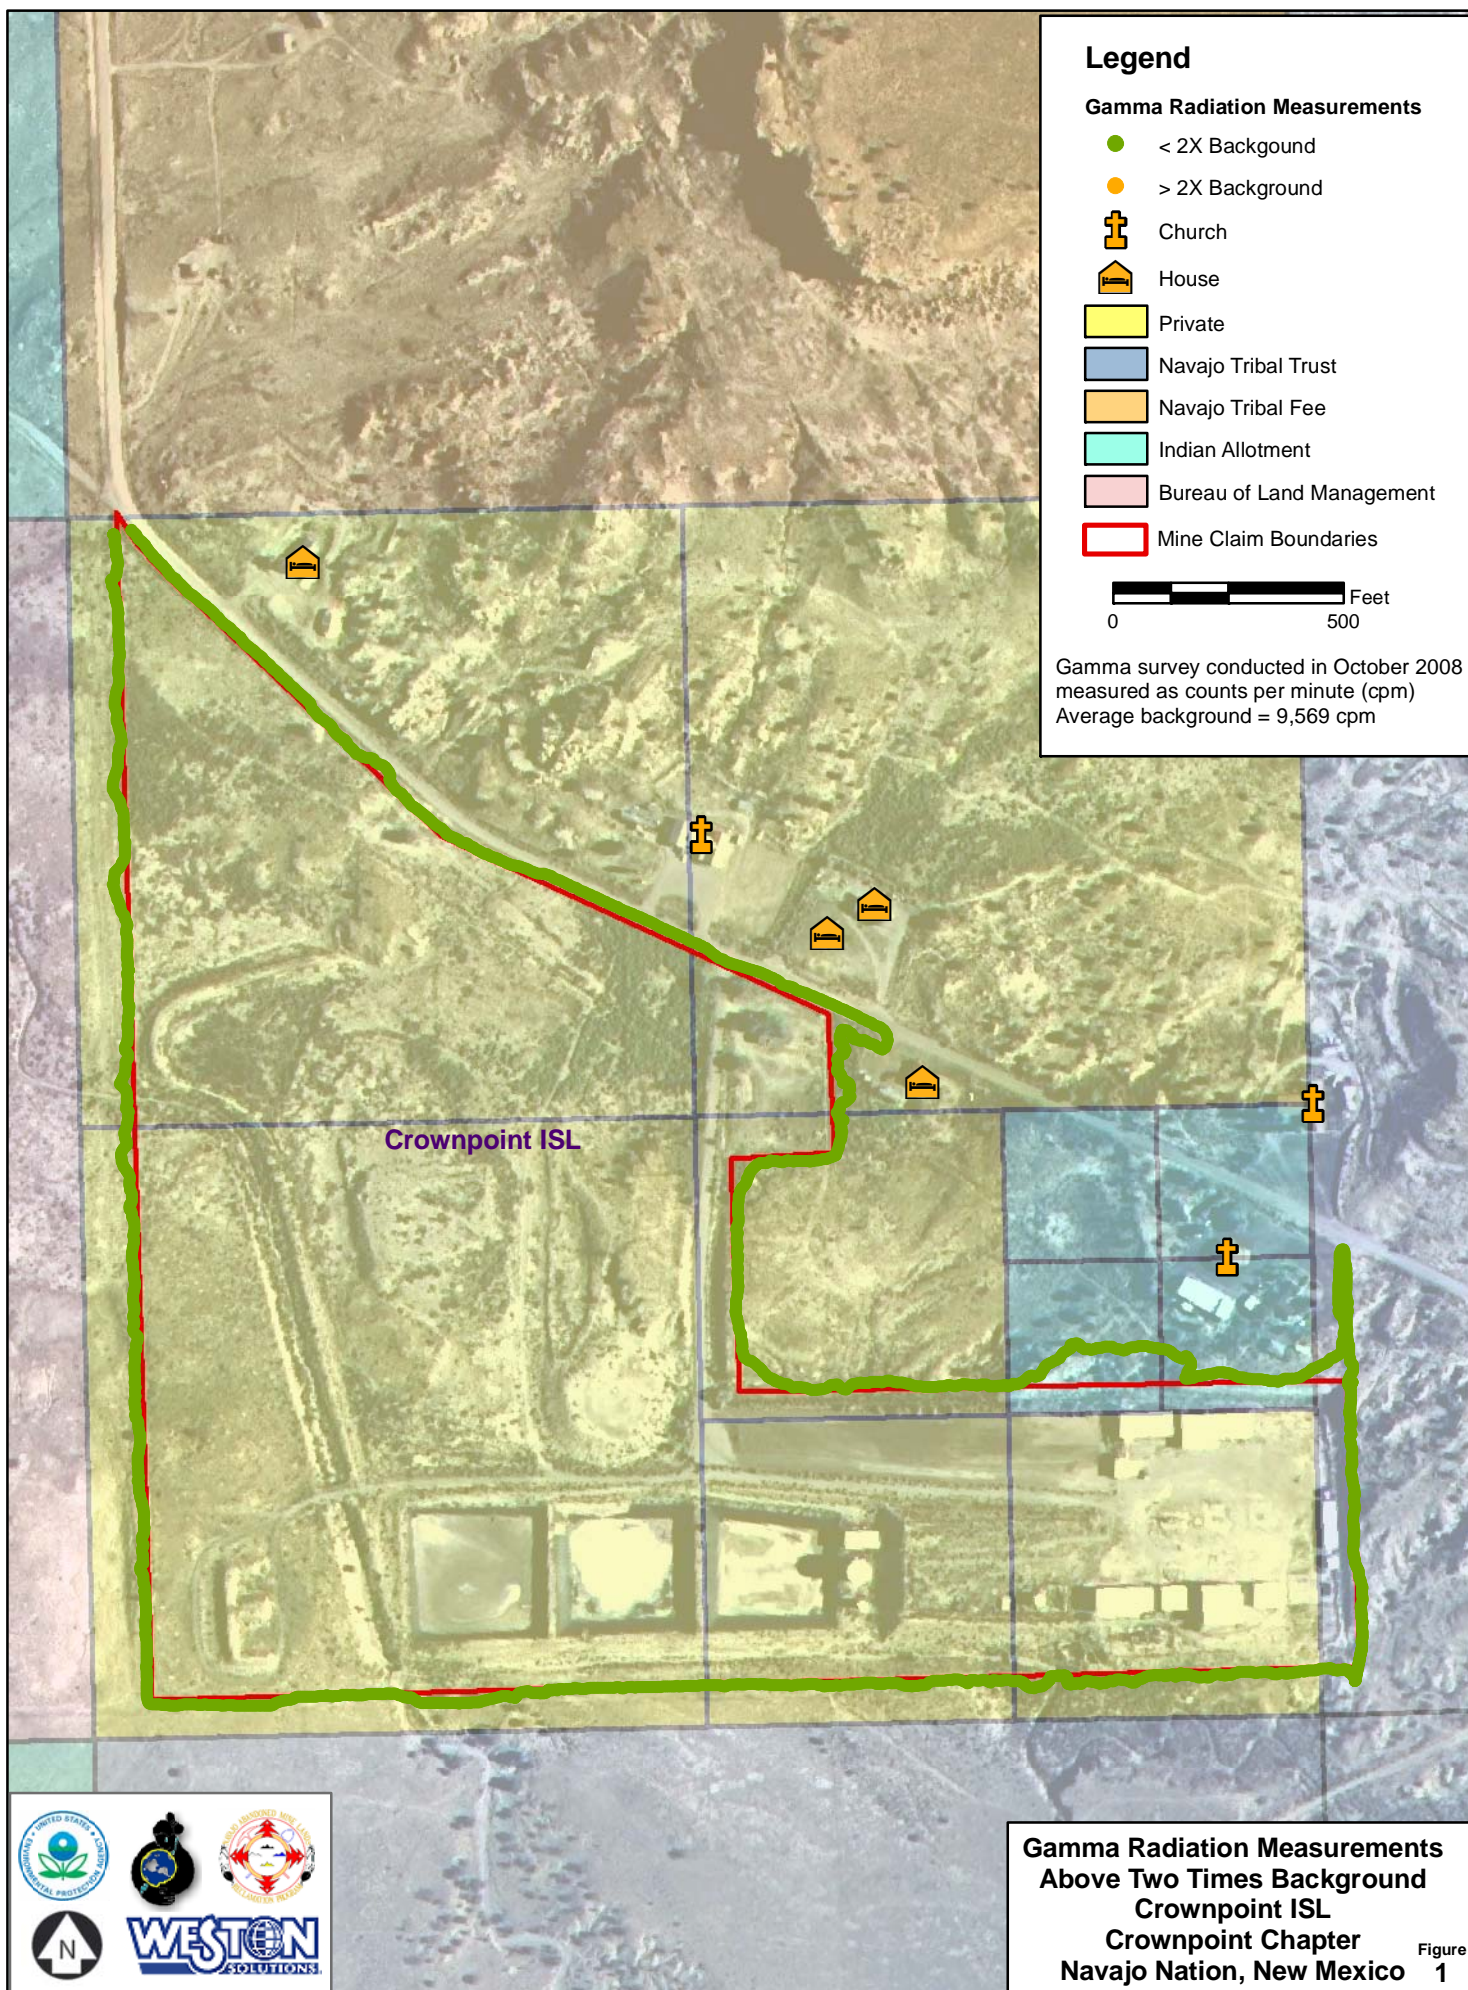
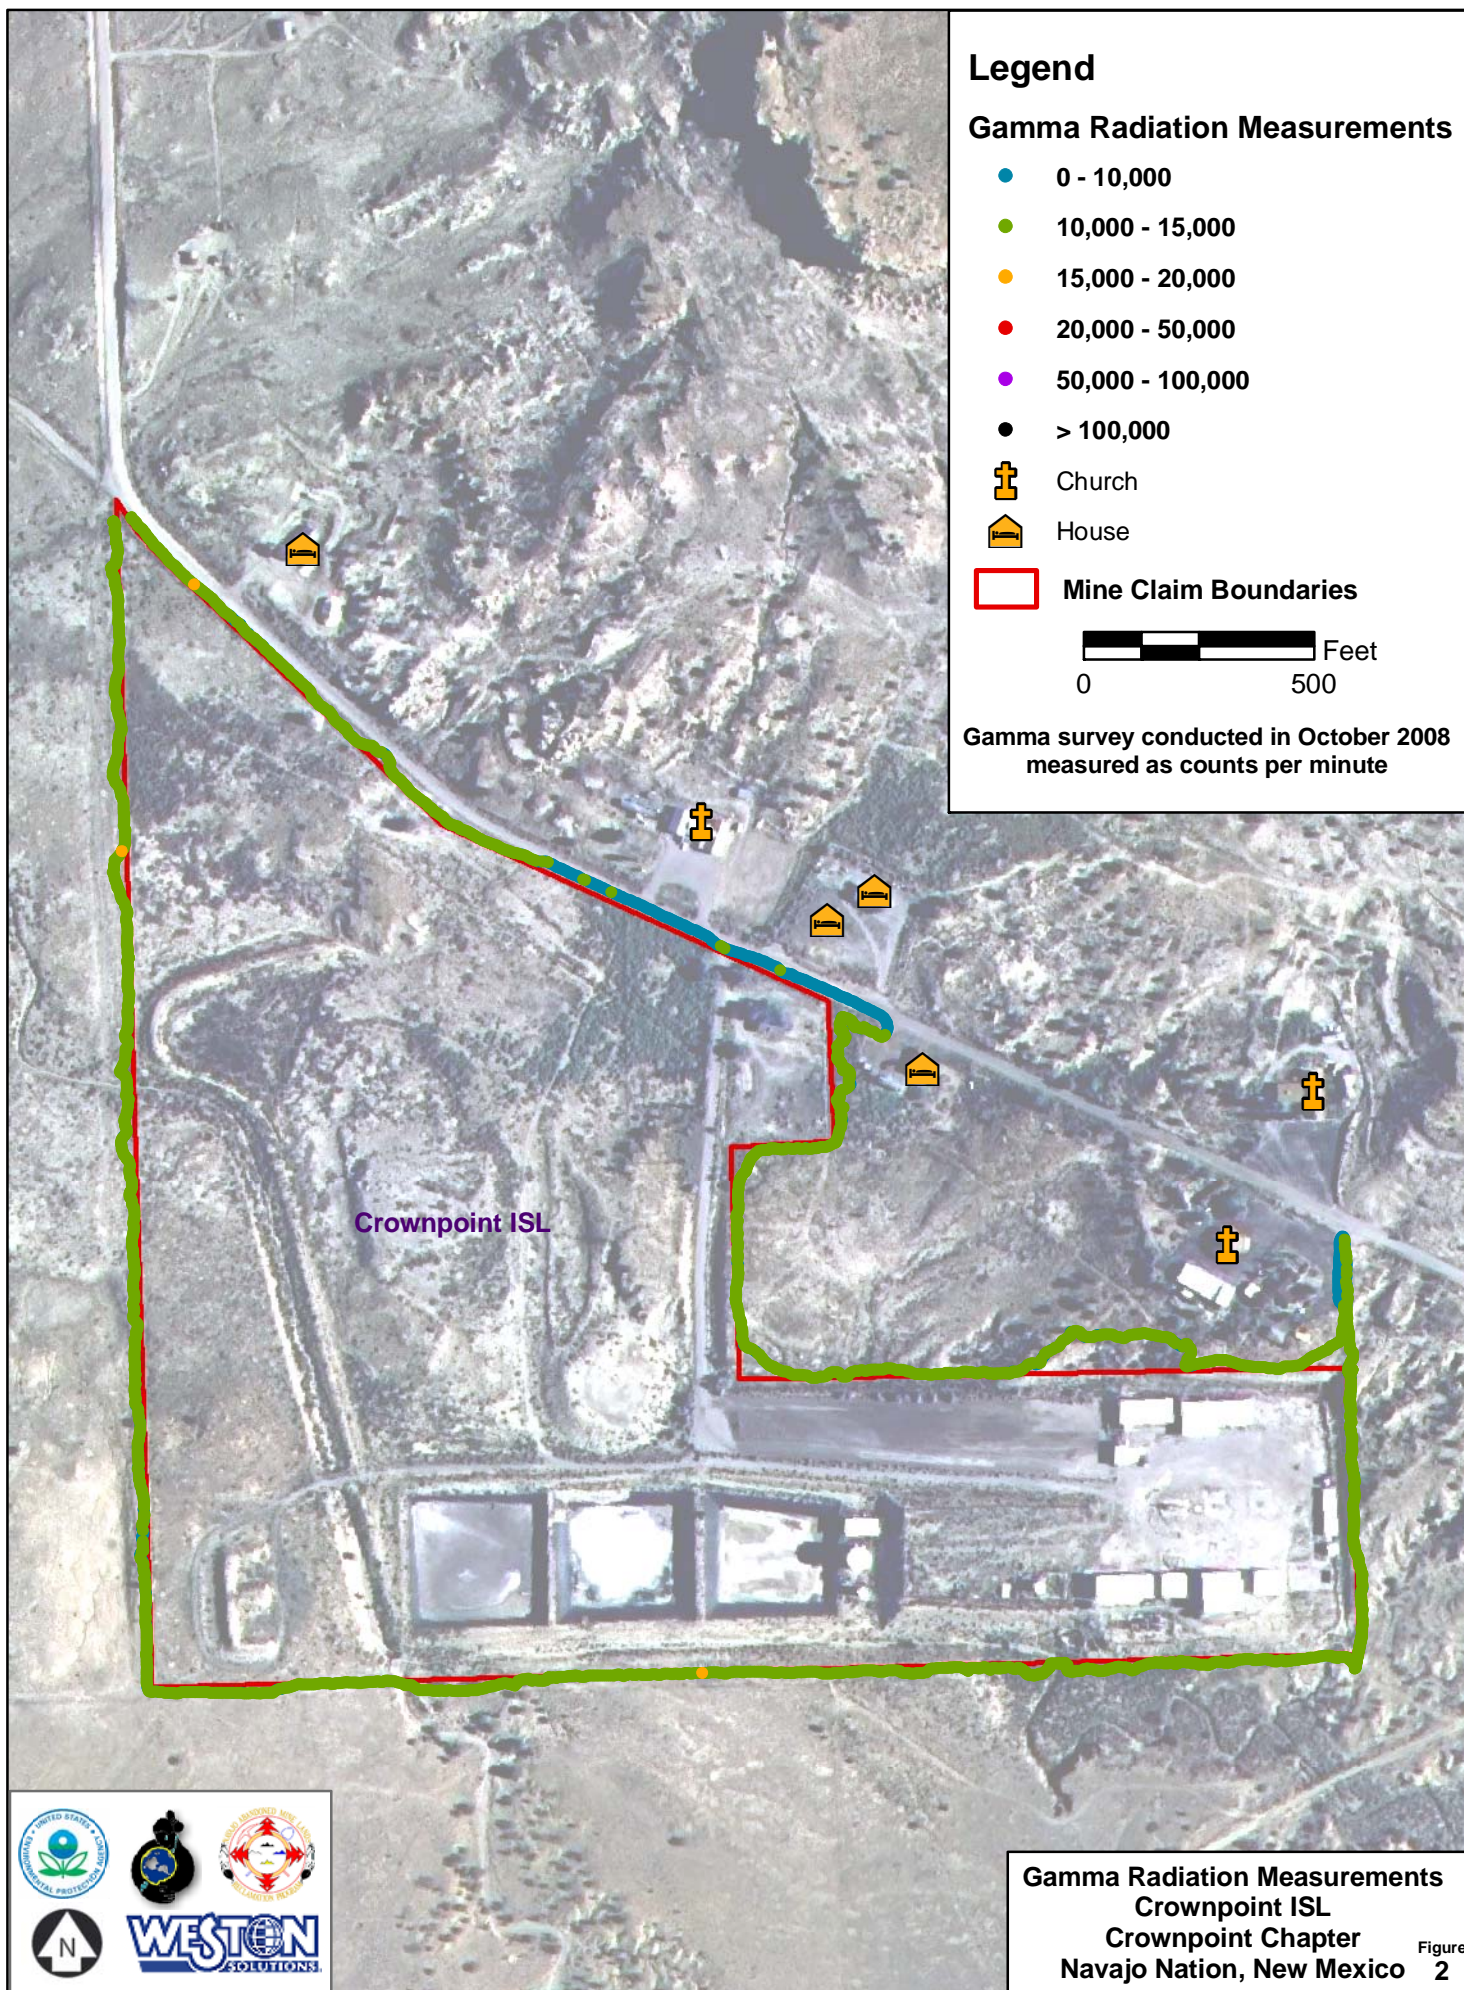
A total of 3,344 gamma radiation measurements were collected from mine sites, ranging from 6,248 cpm to 15,680 cpm. The measurements are represented in Figures 1 and 2.
